Debris/Ice/TPS Assessment and Integrated Photographic Analysis of Shuttle Mission STS-76

*Process Engineering/Mechanical System Division/ET-SRB Branch,
Kennedy Space Center, Florida*

**DEBRIS/ICE/TPS ASSESSMENT
AND
INTEGRATED PHOTOGRAPHIC ANALYSIS
OF
SHUTTLE MISSION STS-76**

22 March 1996

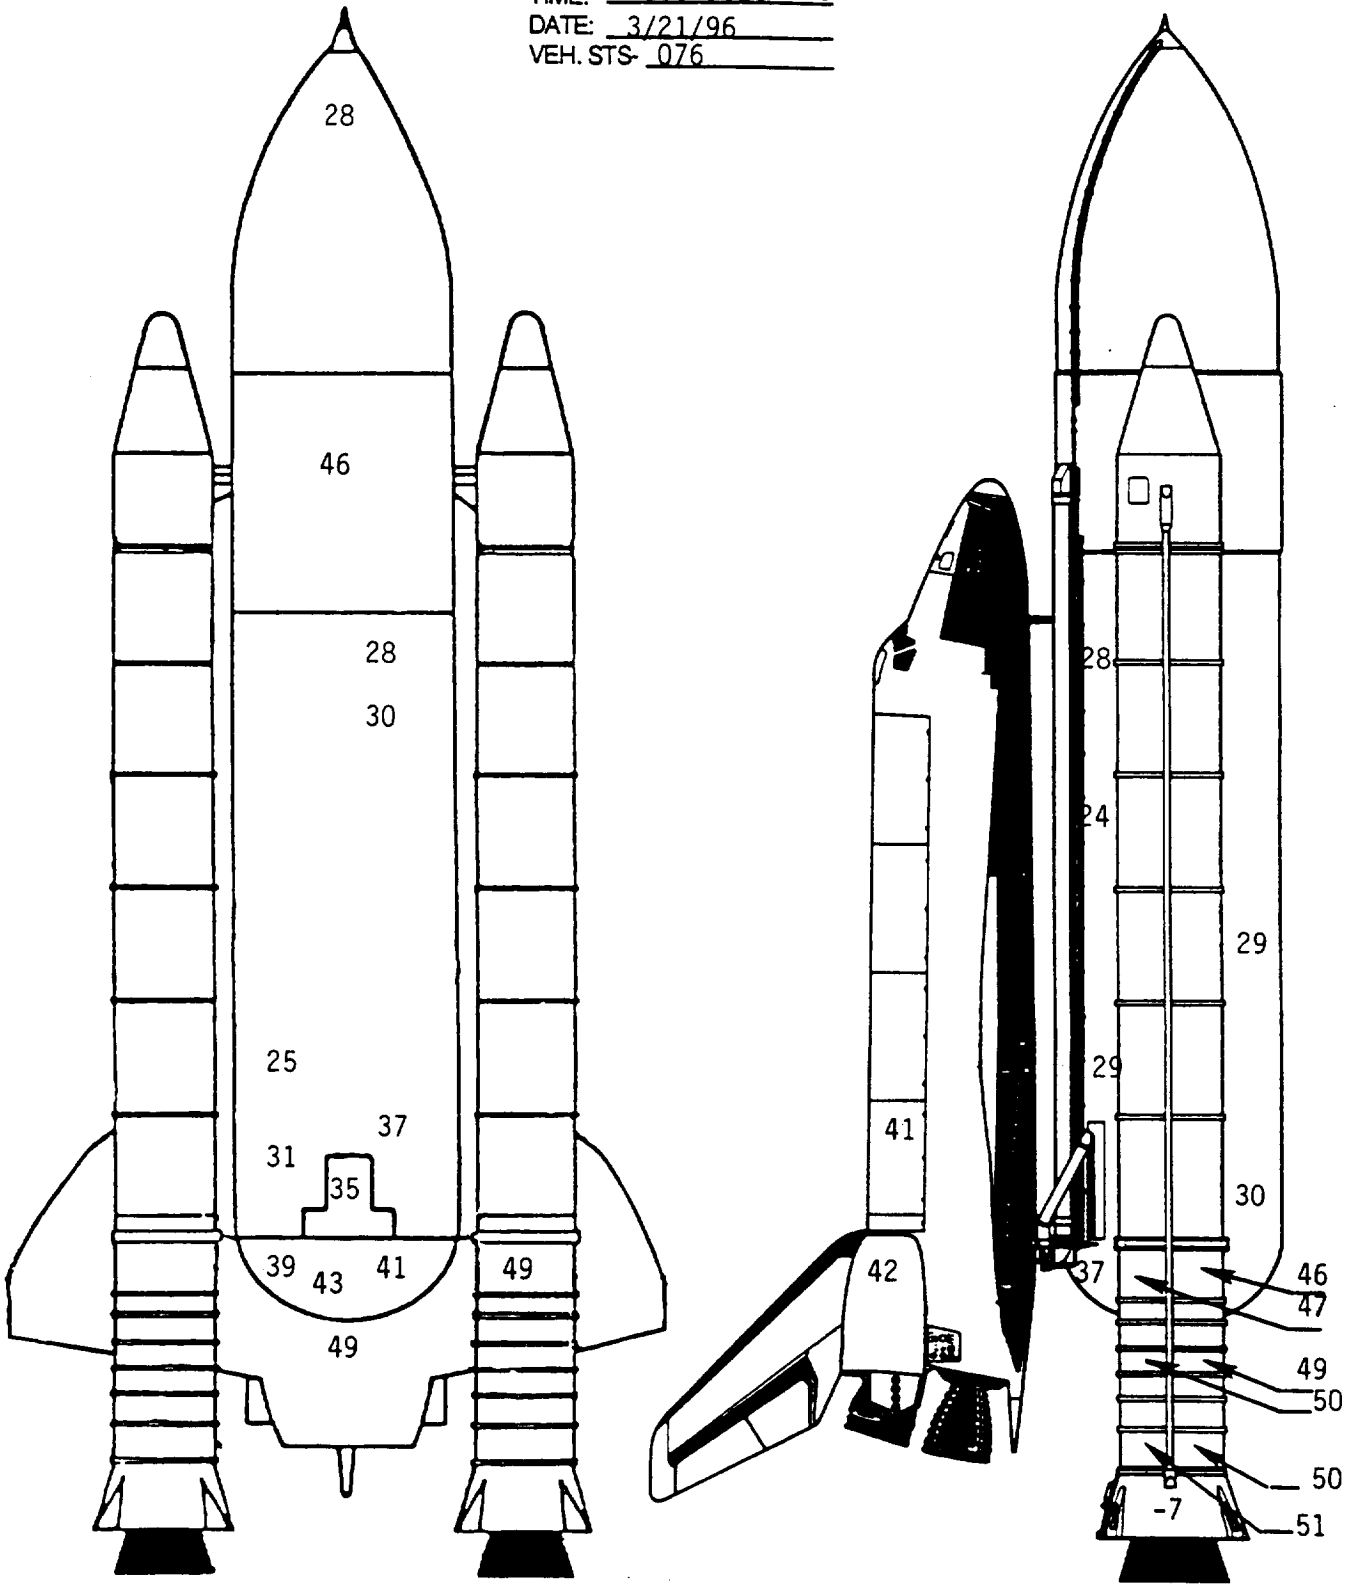
Figure 1: Vehicle Surface Temperature STI Measurements

A portable Shuttle Thermal Imager (STI) infrared scanning radiometer was utilized to obtain vehicle surface temperature measurements for an overall thermal assessment of the vehicle, particularly those areas not visible from remote fixed scanners, and to scan for unusual temperature gradients (Figures 1 and 2).

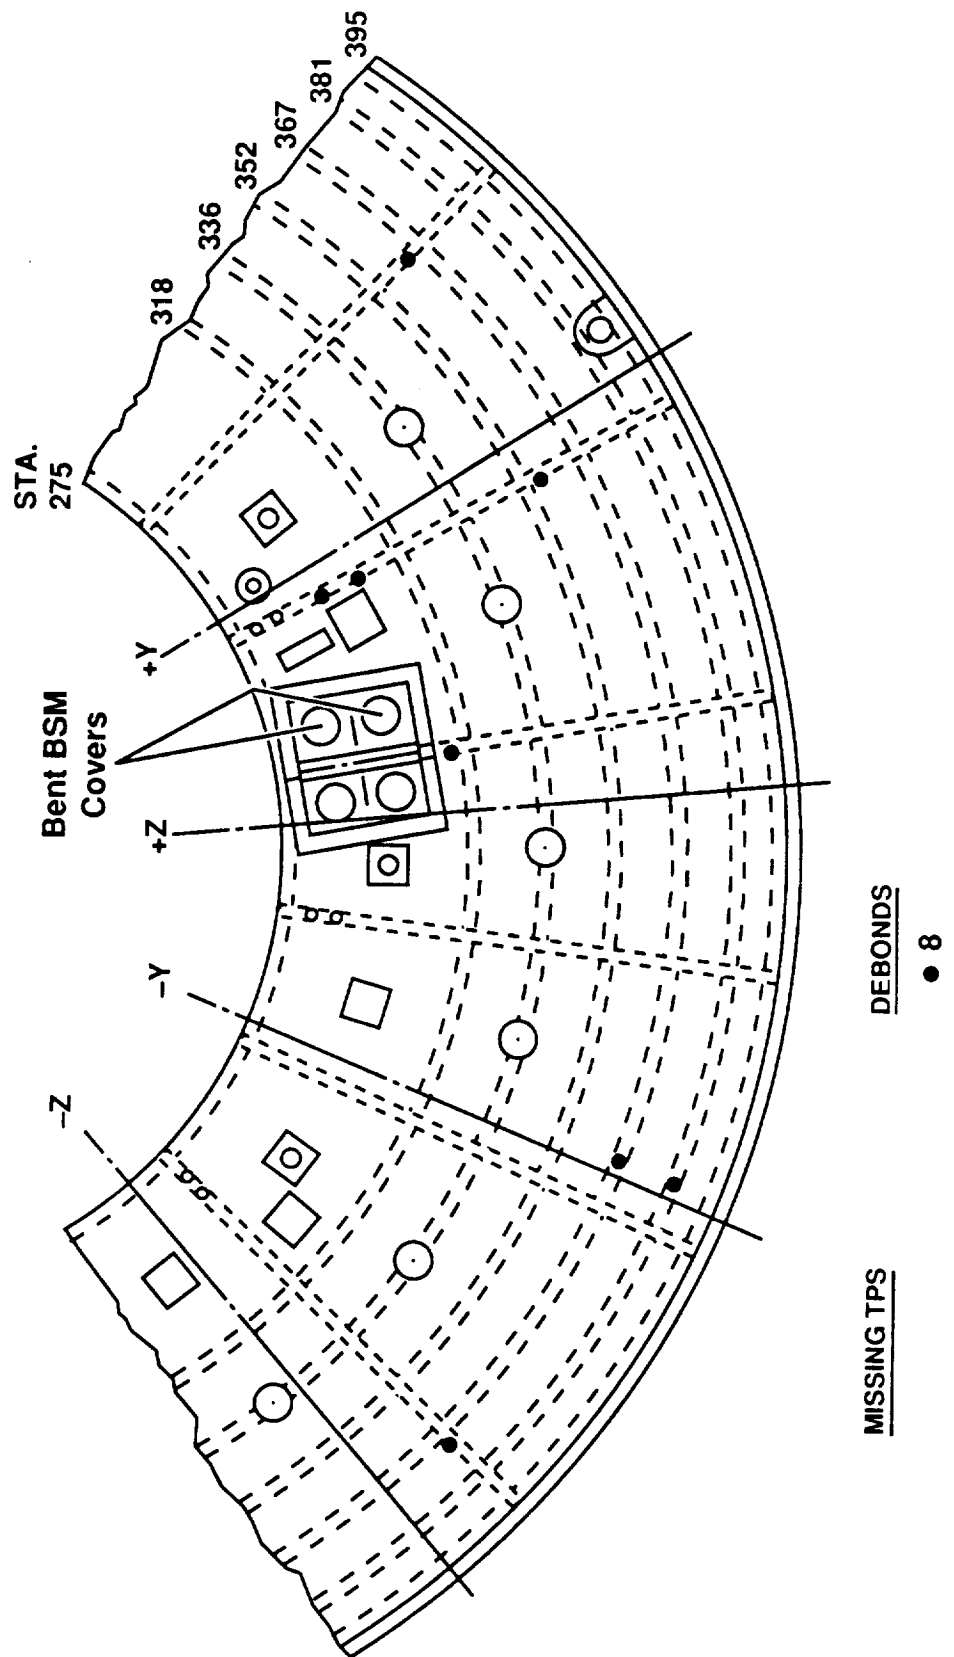
Figure 6: LH SRB Frustum

The LH frustum was missing no TPS. The number of MSA-2 debonds over fasteners (8) was less than average (Figure 5). Hypalon paint was blistered/missing along the XB-395 ring frame where BTA closeouts had been applied. However, most of the exposed BTA substrate was not sooted. The BSM aero heat shield covers had locked in the fully opened position though the right two cover attach rings had been bent by parachute entanglement.

Aft skirt MSA-2 was intact. More than usual amounts of foam were missing from the aft skirt aft ring. This condition was probably the result of the foam adhesion problem documented prior to launch. Launch films showed numerous light colored particles, believed to be pieces of foam, falling along side the SRB plumes during ascent. The HDP Debris Containment Systems (DCS) appeared to have functioned properly and all the plungers were seated.

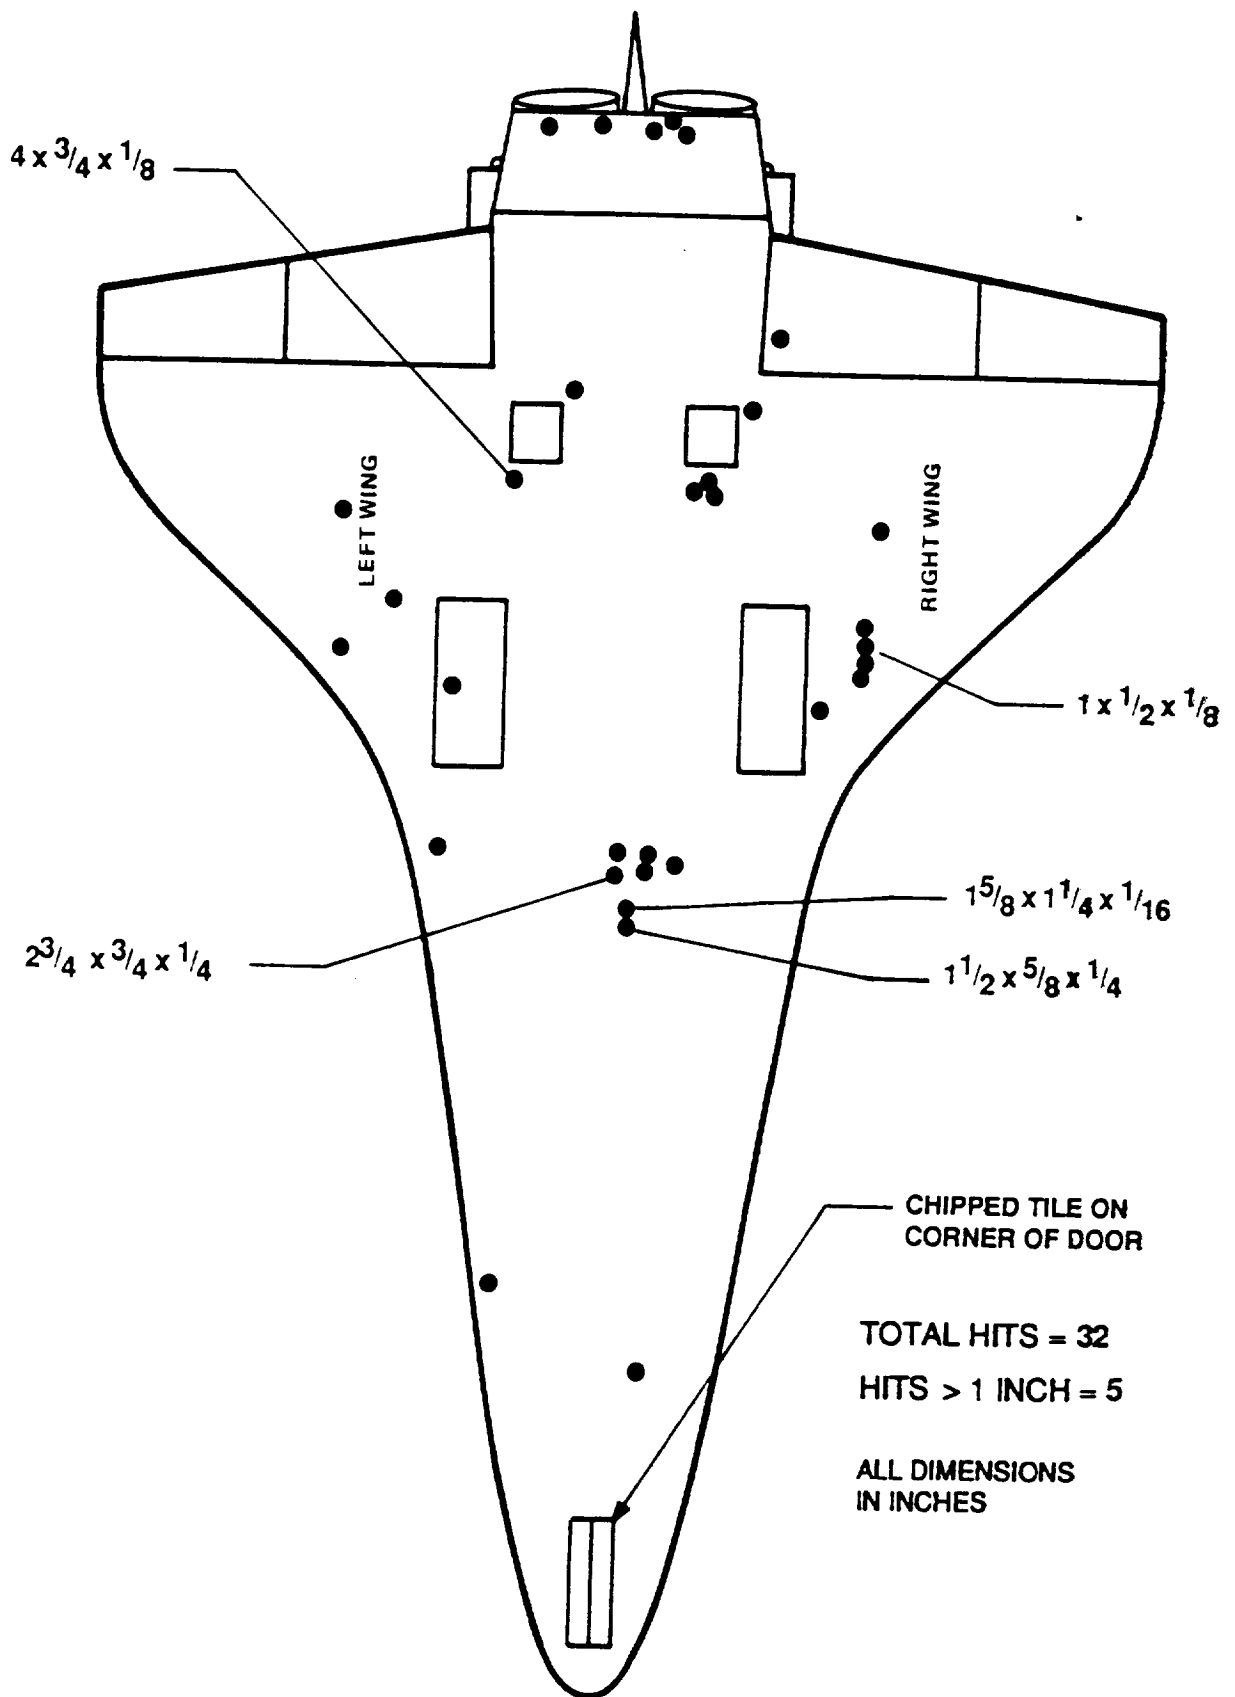
Figure 7: Orbiter Lower Surface Debris Map

The Orbiter lower surface sustained a total of 32 hits, of which 5 had a major dimension of 1-inch or larger. Tile damage sites were generally located aft of the vehicle mid point and approximately equally distributed about the vehicle centerline. A cluster of 7 hits occurred just forward of the main landing gear wells and slightly to the +Y side of the centerline.

In summary, both the total number of Orbiter TPS debris hits and the number of hits 1-inch or larger was significantly less than average when compared to previous missions.

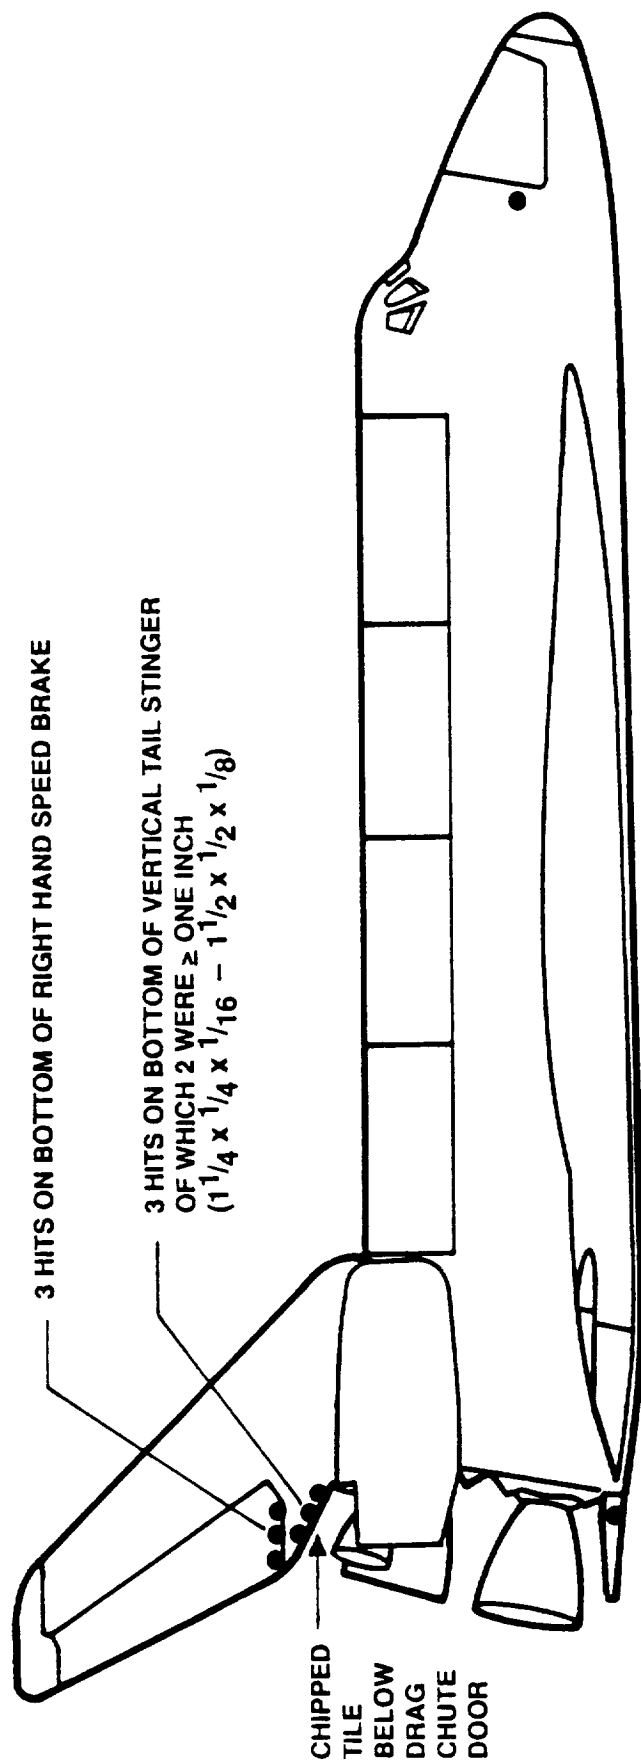
Figure 8: Orbiter Right Side Debris Map

TOTAL HITS = 8
HITS > 1 INCH = 2

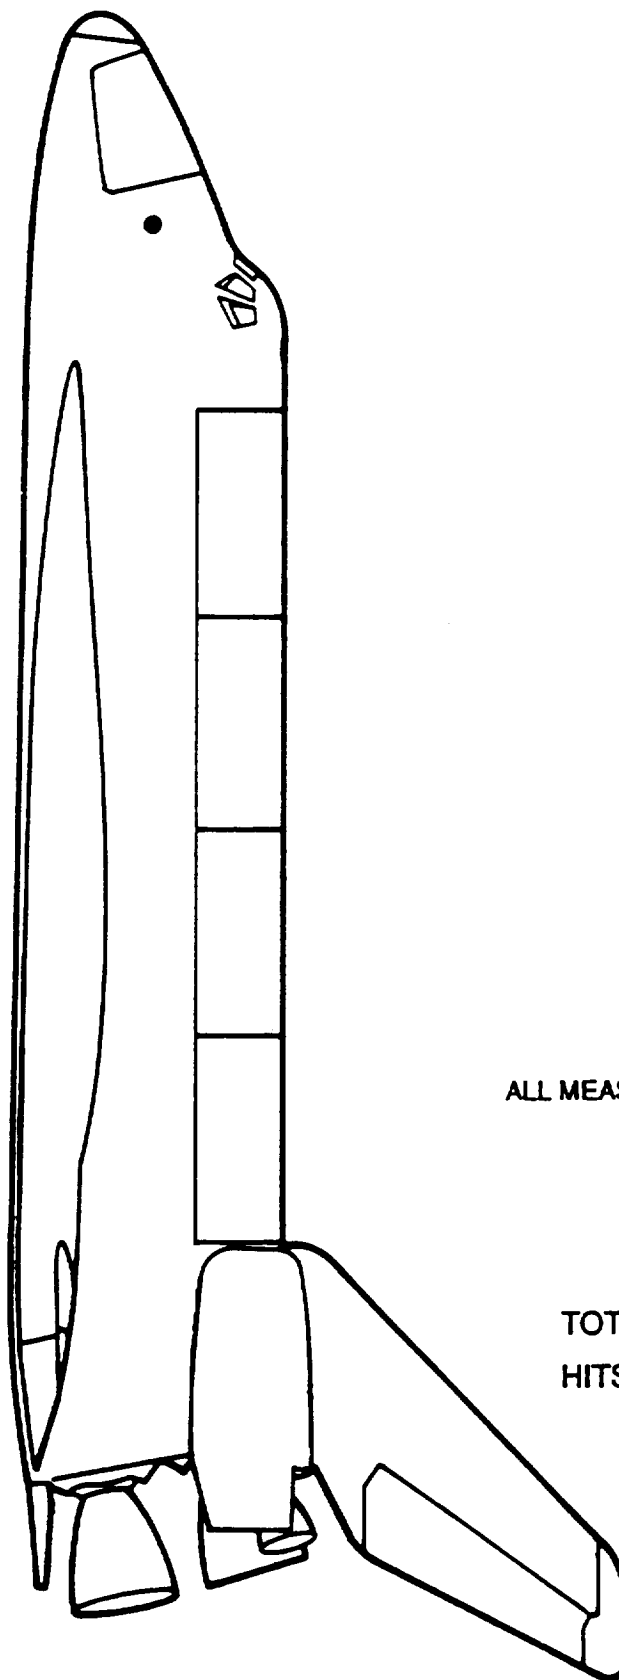
Figure 9: Orbiter Left Side Debris Map

TOTAL HITS = 1
HITS > 1 INCH = 0

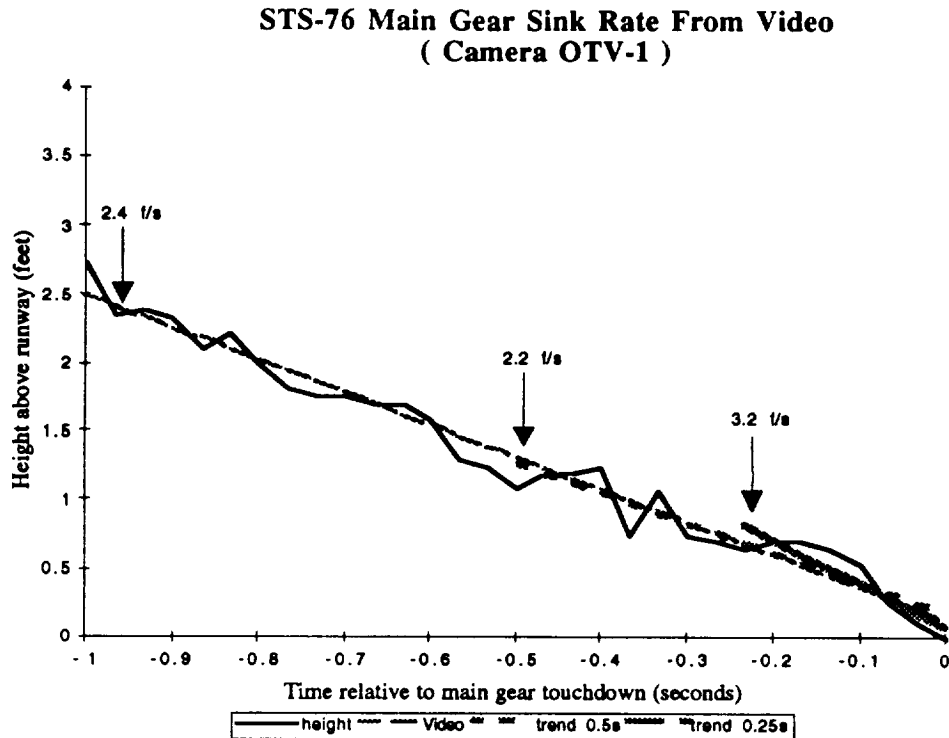
Figure 2.4.1 Main Gear Height versus Time Prior to Touchdown (Video)

The measured main gear sink rate values were found to be below the maximum allowable values of 9.6 ft/sec for a 211,000 lb. vehicle and 6.0 ft/sec for a 240,000 lb. vehicle (the landing weight of the STS-76 Orbiter was reported to be 210,000 lb.). The sink rate measurements for STS-76 are given in Table 2.4.1. In Figure 2.4.1, the trend of the measured data points for film image data is illustrated.
